PEM Fuel Cell Catalyst Layer Structure Degradation During Carbon Corrosion

Rodney L. Borup¹, Rangachary Mukundan¹, Joseph Fairweather¹, Dusan Spernjak¹, David Langlois¹, John Davey¹, Karren More² and Kateryna Artyushkova³

¹Los Alamos National Laboratory, Los Alamos, NM ²Oak Ridge National Laboratory, Oak Ridge, TN ³University of New Mexico, Albuquerque, NM

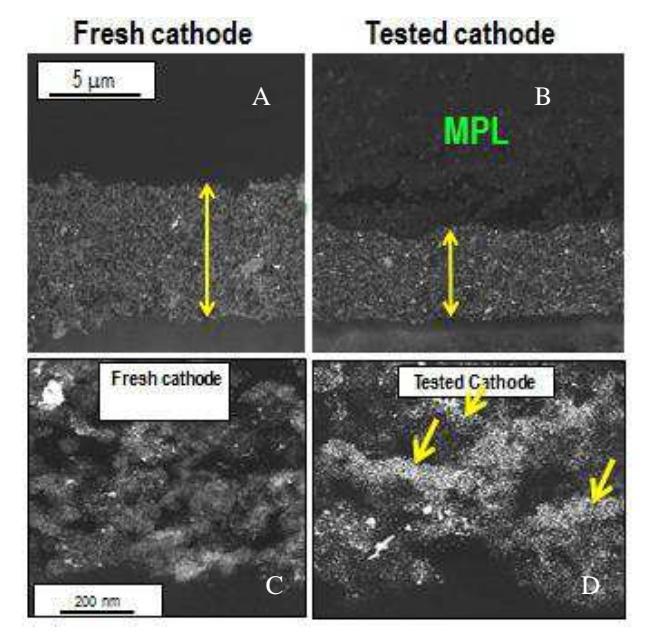
Figure 1. TEM of carbon structure of catalyst layer and MPL before (A,C) and after (B,D) Drive Cycle testing.

The cost of the noble metal used in catalysts makes this a crucial area that requires improvement in durability. The catalyst degradation is due to a combination of degradation mechanisms, with operating conditions and An example of the localized localized effects. degradation is demonstrated in Figure 1 after testing utilizing a simulated Drive Cycle Test prescribed by DOE/Fuel Cell Tech. Team [3]. TEM post-analysis shows significant thinning of the catalyst layer by about 30% (A \rightarrow B) which can be due to loss of carbon through carbon corrosion or due to compaction and loss of void volume. The thinned cathode catalyst layer shows localized changes (C \rightarrow D) and shows a structure of "bands" of graphite oxide, partially oxidized carbon and relatively unchanged HSAC (High Surface Area Carbon). These bands are primarily direction with respect to the membrane.

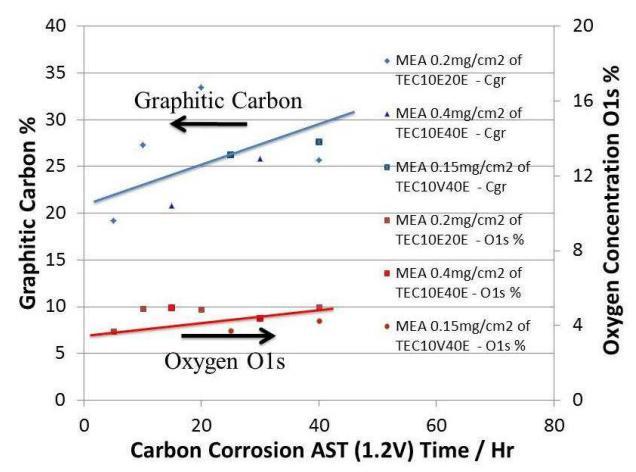
Figure 2. Compositional changes of the catalyst support carbon as a function of AST testing time.

To rapidly evaluate materials we employ Accelerated Stress Tests (ASTs); to evaluate the cathode support material, a potential hold of the cathode at 1.2V was used. Figure 2 shows changing elemental composition of the carbon in the catalyst layer as a function of time at the corrosion potential. An increase in the graphitic content of the carbon is observed, likely due to the loss of amorphous carbon material due to carbon corrosion. In addition, an increase in oxygen content of the catalyst layer is observed compared with fresh samples; this is likely formation of surface oxides.

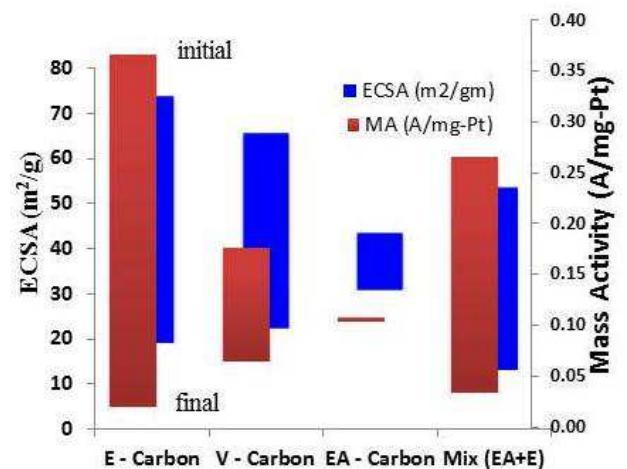
Figure 3. Waterfall Plot of mass activity and ECSA for catalyst support carbons (a) E carbon (High Surface Area), (b) Vulcan carbon and (c) Ea (graphitized) carbon. Initial and final performance after carbon corrosion AST.

To reduce degradation due to corrosion of the support material, different carbon supports have been employed, but typically at the cost of lower initial performance. Figure 3 shows a Waterfall Plot for three types of carbon, (E – High Surface Area Carbon, HSAC, V – Vulcan, Ea – graphitized) plus a case where graphitized carbon was mixed with High Surface Area Carbon to prevent the loss of catalyst layer porosity and retain higher performance.
