A new look at top of the line corrosion. A special case of flow induced corrosion which is due to electrochemical reactions in the hydrodynamic diffusion layer.

M. Reda

CanadElectrochim

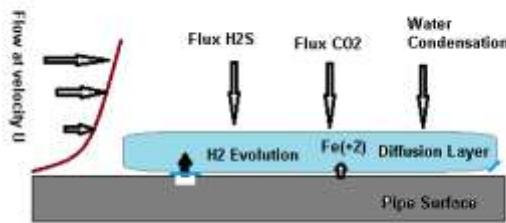
Figure 1: Enlarged section of a pipe where in the diffusion layer hydrogen evolution can increase pH and mixing can increase dissolution flux of  $\text{H}_2\text{S}$  and  $\text{CO}_2$ .

Top of the line corrosion is a phenomenon encountered in the oil and gas industry due to the flow of wet gas or oil in stratified flow regime (Flow Induced Corrosion). The problems of corrosion appear at the surface of a pipe due to condensation of water containing dissolved corrosive gases (carbon dioxide and traces of hydrogen sulfide) and organic acids. Corrosion will occur in the hydrodynamic diffusion layer (of thickness  $\delta$ ) at the surface of the pipe where dissolved organic acids (e.g. acetic acids) will cause hydrogen evolution. Not only the pH will increase in the diffusion sublayer due to hydrogen evolution but also mixing will increase the dissolution of hydrogen sulfide and carbon dioxide. The pH of the hydrodynamic diffusion layer will determine whether intensive corrosion or formation of a physical protective layer may occur. This is because bicarbonate or carbonate ions will form upon dissolution of  $\text{CO}_2$  and bisulfide and sulfide ions will form upon dissolution of Hydrogen sulfide. Furthermore it is well known that Fe-carbonate and Fe-sulfide are not soluble in water. Thus the protective property will depend on the pH value of the hydrodynamic diffusion layer.
